AIRWAYS CLASSICS N° 2

TWA Flight 800

The Devil is in the Details

by Robert W Allardyce & Captain Howard Mann (TWA, retired)

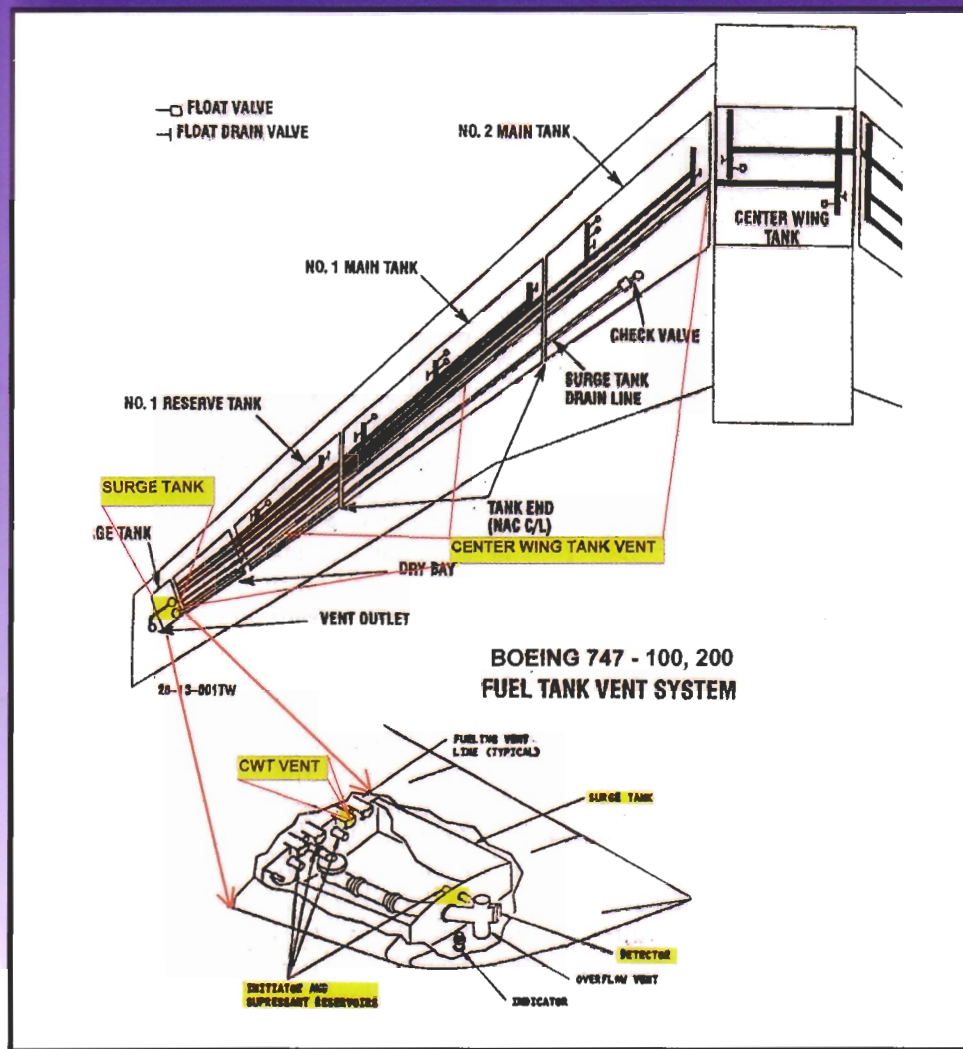
Highlighted in yellow, the photoelectric sensor was mounted on the outboard wall of each surge tank opposite the open end of the CWT's tank vent. Had a flame-front emerged from the CWT's tank vent, that photoelectric sensor was positioned to detect it and, within nanoseconds, flood the surge tank with inerting gas. Here is what the NTSB offered: "Although details of fire and soot documentation were performed by the Fire/Explosion Group, general observations of fire damage (or lack thereof) to the airplane systems were

made by the Systems Group." Toward the end of the paragraph the NTSB added, "Soot was found in the vent stringers routed beyond the CWT to the right wingtip, but components in the wingtip surge tanks were not burned. The Surge Tank Protection (STP) system extinguishing agent had not been discharged from the intact bottles."

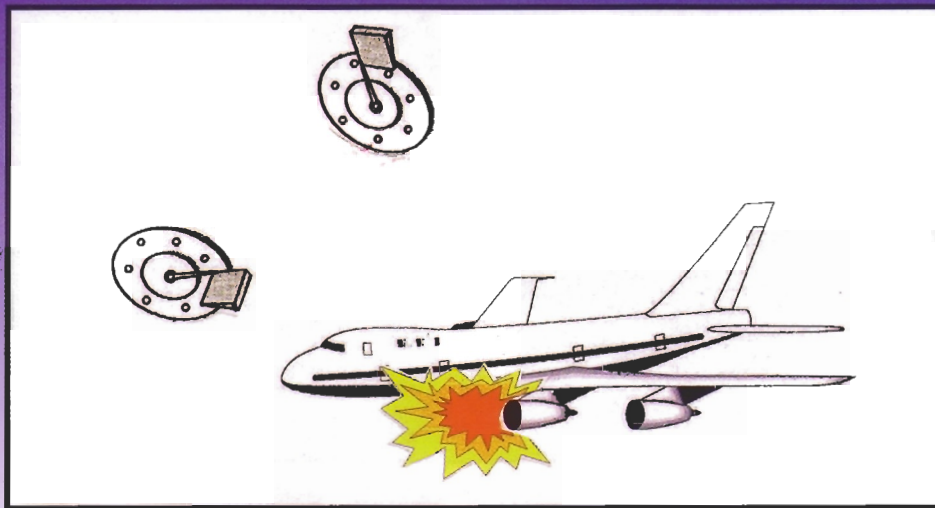
threads and is fractured at the bottom of the fitting." The jack screw had indeed broken free. However, the NTSB attributed this to damage done upon impact with the water; it can be no more than a convenient guess. Consistent with the evidence, the damage occurred in flight as a result of the severe impact of a powerful shock wave resulting in an instant and severe pitch-up.

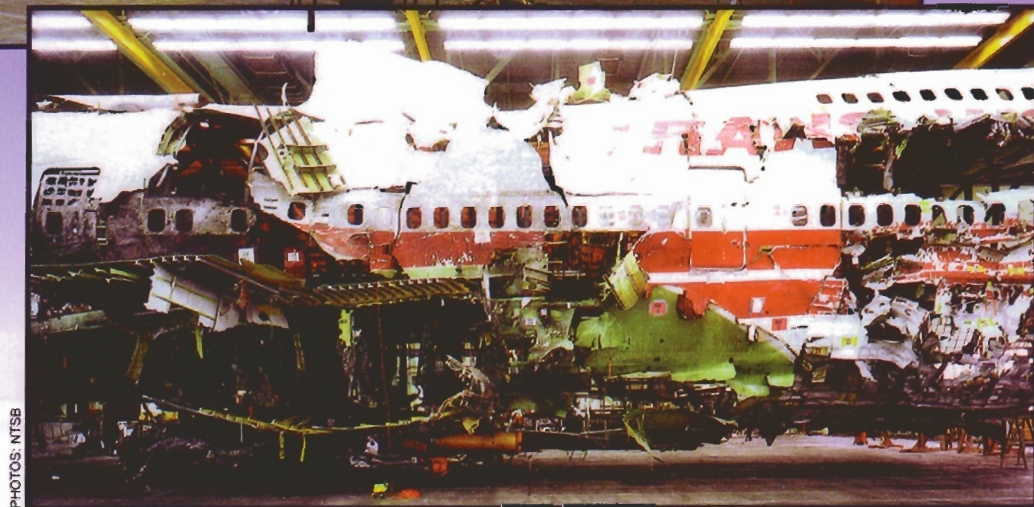
TWA 800 fuselage reconstruction. A photograph taken by the NTSB of the left side of the fuselage. The site of the breach was roughly abeam the L2 door.

Original fuselage reconstruction. Another NTSB photograph shows that, unlike the left side, the skin of the right side of the forward section is splayed outward (that is from left to right). This is the result of a linear rather than an expanding omni-directional force emanating from the opposite side of the airframe.

complicated mathematical calculations and was able to triangulate the epicenter of the blast. Accordingly, Donaldson placed the epicenter near the "Low[er] left side [of the fuselage]...abeam aircraft station 576." Donaldson adds: "9 feet [2.74m] below the aircraft belly line [and] 17 feet [5.18m] from closest aircraft hull" (left). An NTSB diagram depicts the L2 door, located nearly abeam the epicenter of the explosion, having been blown loose and expelled from left to right. The opposite would have been true had the explosive pressure emanated from the CWT.
